A Summary of Proposed Improvements to Reclaim the Pathway

Presented by: Lee Hixon, Town Engineer

Woodbine Has a DRAINAGE Problem!

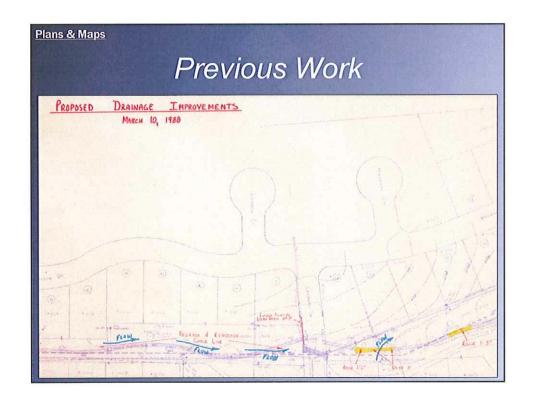
Drainage Planning

- All drainage structures, ditches, and street shoulders shall be maintained by the Woodbine HOA (privately), except culverts under public streets.
- Common area to be owned and maintained by Woodbine HOA
- All common areas dedicated as PUE & DE
- 15' PUE & DE dedicated centered along all lots and interior to boundary lines
- Pedestrian walkway shall weave in places as to retard stormwater velocity

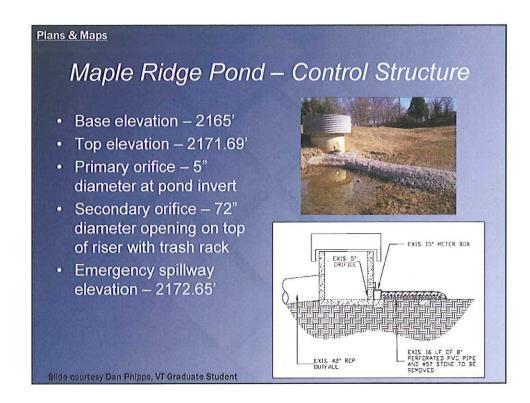
Maple Ridge Pond - Control Structure

- Control structure modifications
 - Reduce duration of out-flow to < 2 days
 - Will raise peaks slightly
- Water Quality regulations
 - Extended detention

Storm	Pre-development (cfs)	Current Condition (cfs)	Proposed Condition (cfs)
2-yr	28.4	1.2	0.89
10-yr	90.47	1.6	4.9
100-yr	163.57	25.4	20.2
